Manhole Inspection Summary

Manhole # S31I__017MH

Insp Date: **10/29/08 1:31 PM**

Location Address: **301 s eutaw st**

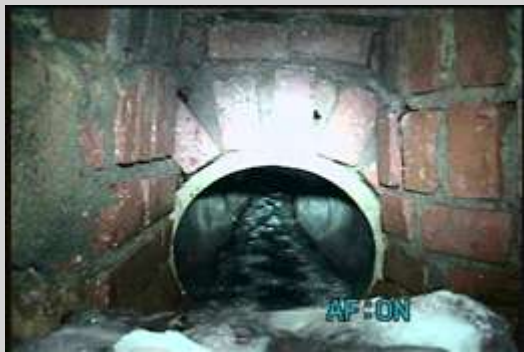
12 O'Clock Outflow

10 in. Circular Gravity Sewer
Pipe Out @ 12 O'Clock

Invert Depth: **15.20** (ft.) Flow Characteristics: **Fast**

Infiltration: **None** Pipe Seal Cond: **Unknown**

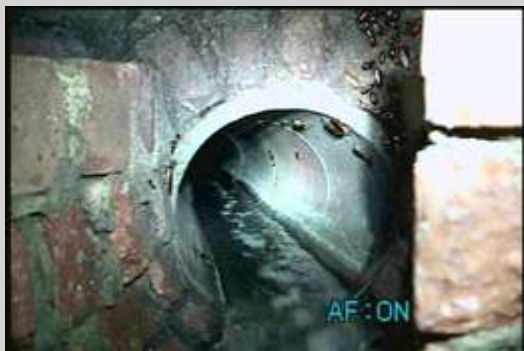
3 O'Clock Inflow

10 in. Circular Gravity Sewer
Pipe In @ 3 O'Clock

Invert Depth: **14.80** (ft.) Flow Characteristics: **Fast**

Infiltration: **None** Pipe Seal Cond: **Unknown**

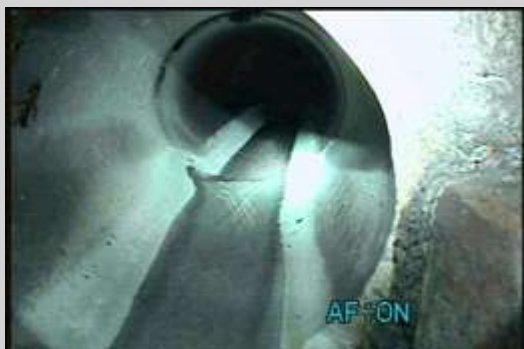
9 O'Clock Inflow

8 in. Circular Gravity Sewer

Infiltration: **None** Pipe Seal Cond: **Unknown**
